## Bohannon Creek

### Water Quality Concerns

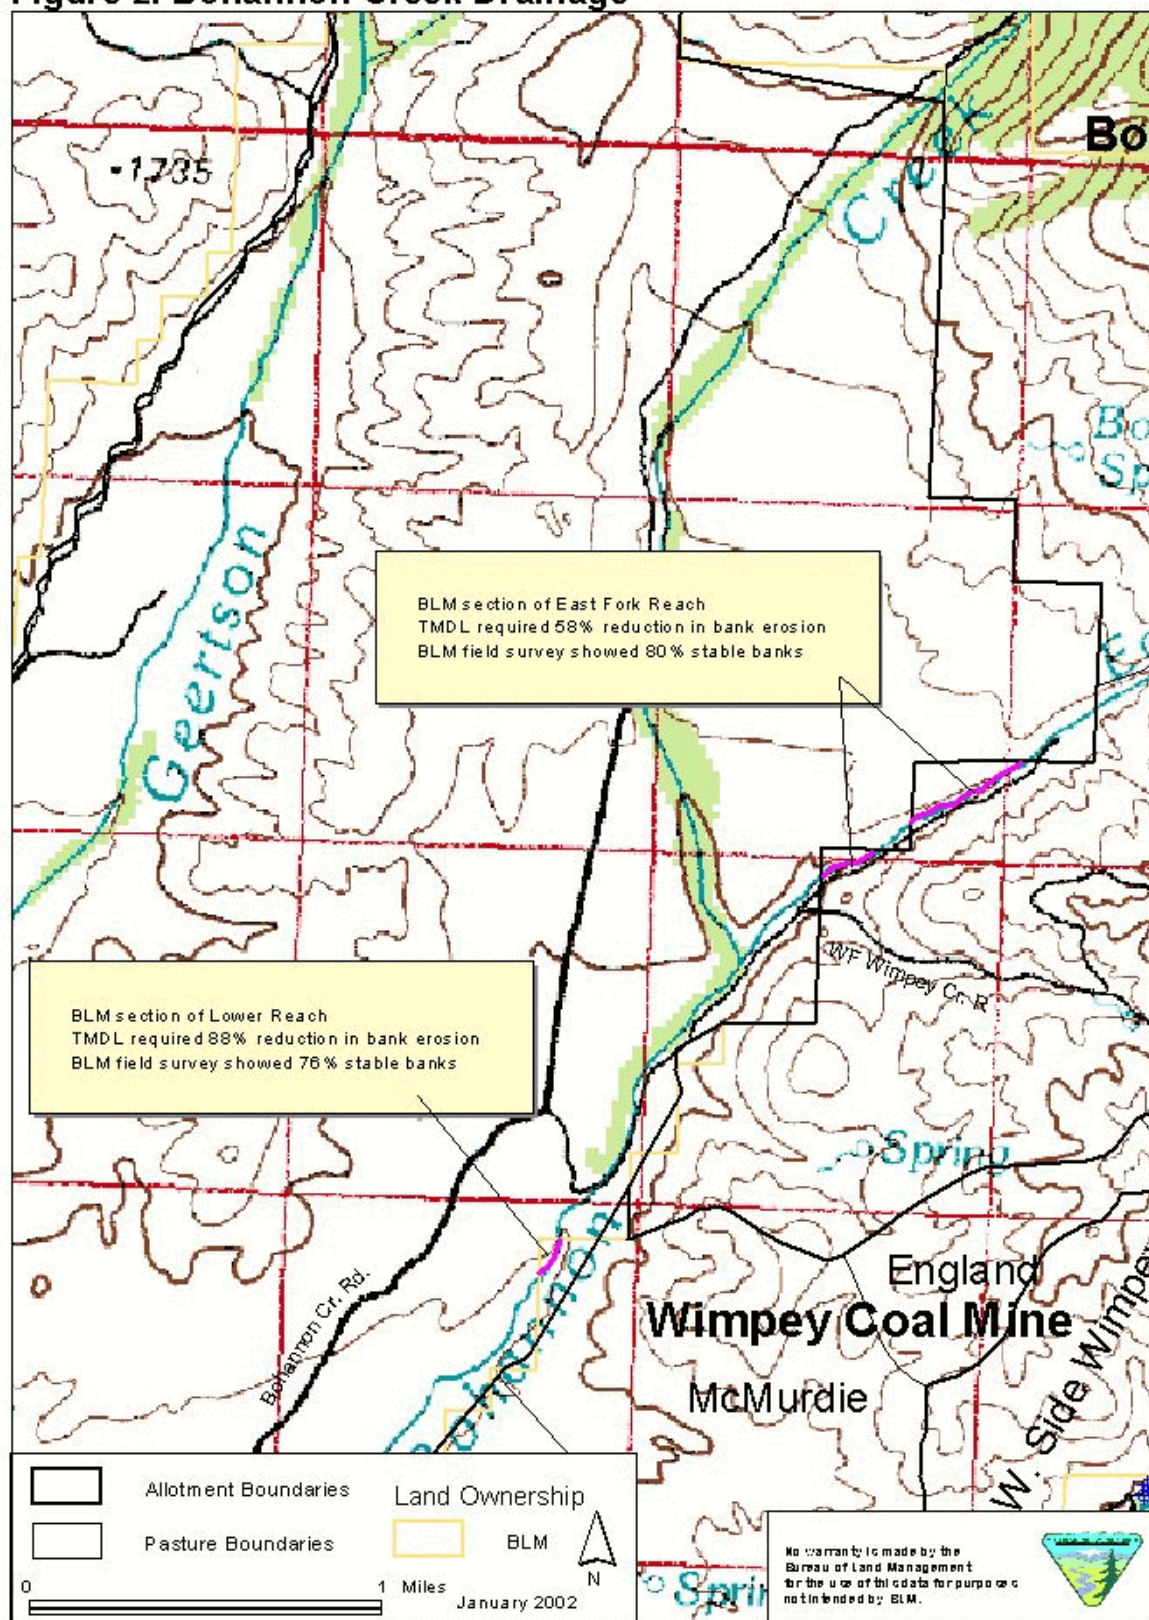
**Figure 2. Bohannon Creek Drainage**

In 2001, the BLM surveyed bank stability on the sections of the East Fork and Lower Bohannon Reaches crossing BLM land. Results are listed in Table 3 and shown in Figure 2.
